## NEAR-MISS REPORTER

# Safety Takes You Further

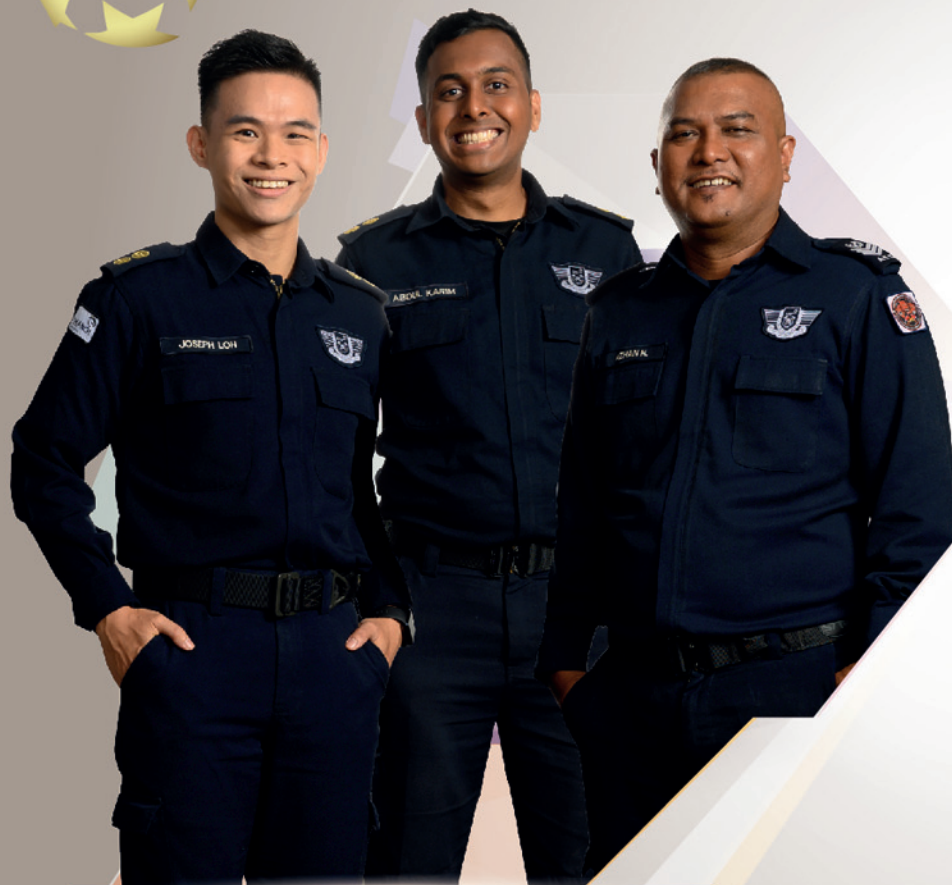
On 17th of May 2023, the AES vehicle (UT4) embarked on a journey from Fire Station 3 towards the IEPL workshop, traversing the west perimeter road. As they approached the green traffic signal, the driver proceeded to navigate Taxiway M6. Just a few metres beyond the traffic signal, Mr Azhan Bin Hussein and Mr Joseph Loh were alert as they spotted two aircraft suddenly appearing before them at the W2B gate. Swiftly responding to the situation, the driver, Azhan, promptly halted and reversed the vehicle after looking out for blind spots.

The traffic light operates on a timer which had elapsed while the pilot was awaiting ATC clearance without resetting the timer. Fortunately, the vigilant AES officers skilfully handled this situation, ensuring they didn't cross paths with the taxiing aircraft.

Following the occurrence, pilots are reminded to reset the traffic light if 9 minutes have elapsed. Airside drivers, even with a green light, must stop and check for approaching aircraft. Consideration is underway for aircraft-detection sensors, reducing manual activation. All traffic light signals follow a standardised display of flashing amber or red.
